April 2007

LOUISIANA DEPARTMENT OF ENVIRONMENTAL QUALITY

# aerial survey of the mississippi river industrial corridor using the hawk infrared camera

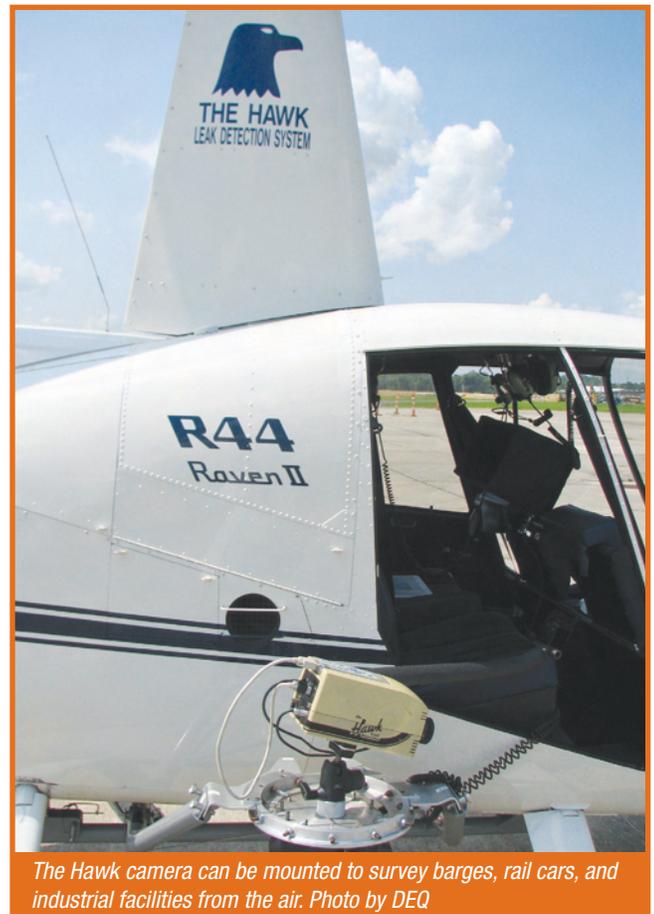
*The Hawk camera can be mounted to survey barges, rail cars, and industrial facilities from the air. Photo by DEQ*

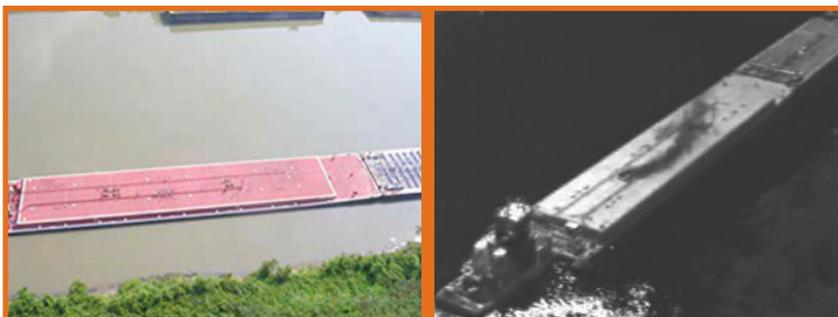
*The color photo of this barge shows what the human eye sees. The black and white photo shows the Hawk detecting a hydrocarbon leak. Photo by Leak Surveys, Inc.*

During the three-day study, a high number (more than 10 percent) of chemical tank barges were found to be releasing large amounts of organic vapors into the environment. The Hawk camera was highly effective in visually detecting leaks from barges. When one leak from a barge was encountered, additional large leaks were often found from that same barge.

Sources of the leaks have included hatch cover leaks, leaking vent stacks, failed gaskets and valve packing seepages.

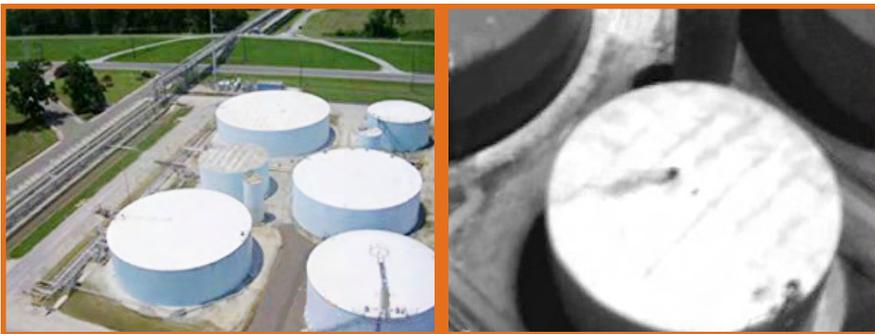
*The Hawk detects a leaker at a tank farm at an industrial facility which is identified by the black and white photo. Photo by Leak Surveys, Inc.*

A considerable number of fixed bulk storage tanks were identified as leakers at petrochemical facilities located along the river. In many instances, the field crew was able to meet with company representatives on the same day to make sure they were aware of the leaks. All facilities were encouraged to take appropriate actions to address leaks found using the Hawk camera to ensure they were compliant with applicable laws and regulations. Within the limited time allotted for this project,

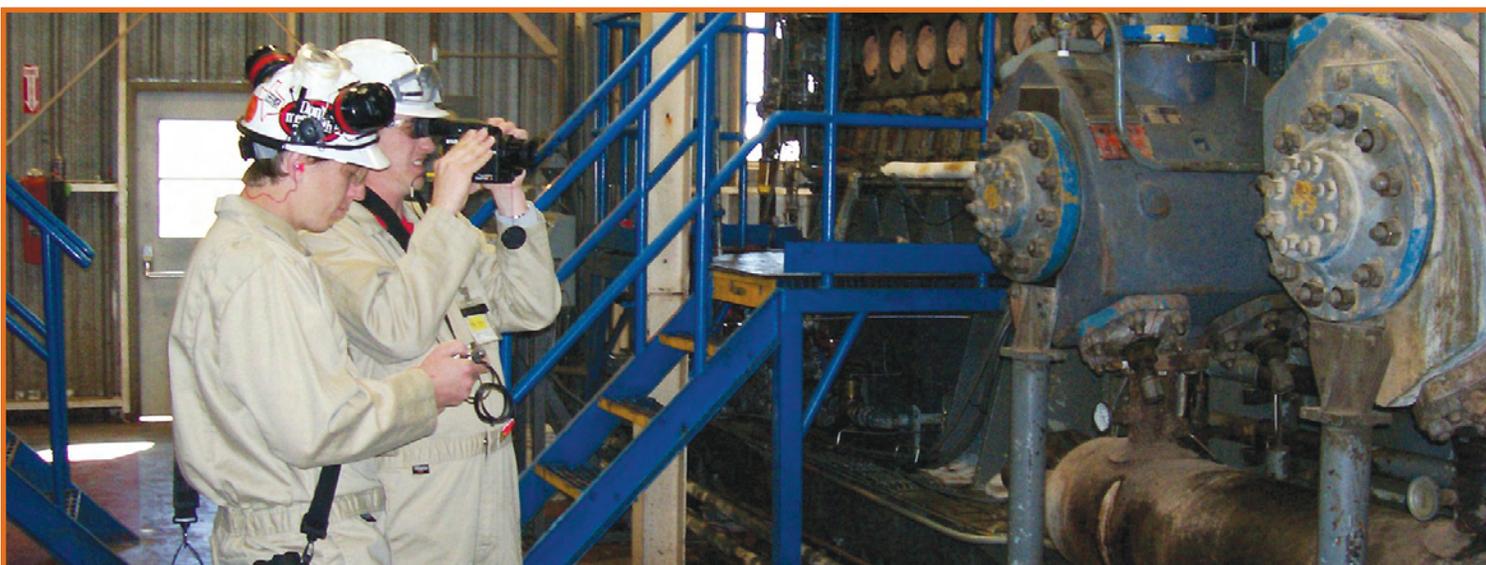
*A team from Leak Surveys, Inc., inspects various sections of a gas processing plant in north central Texas. The Hawk looks for leaks in compressors, control valves, flanges, and unions. Photo by Leak Surveys, Inc.*

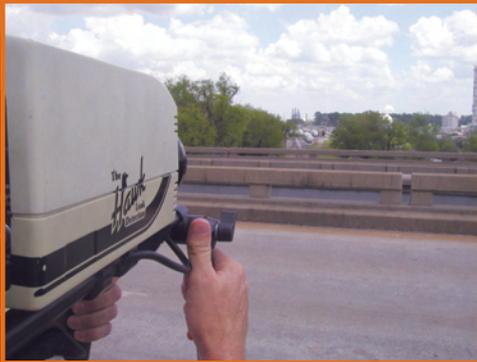
*The Hawk scans a sector looking for leaky rail cars.  
Photo by DEQ*

Although several thousand railcars were checked from the helicopter, none were found to be leaking during the project. However, based on earlier work, such leaks had been anticipated. At this time, it is uncertain if there were no leaks or if leaks from railcars were not detectable with the Hawk camera from the air.

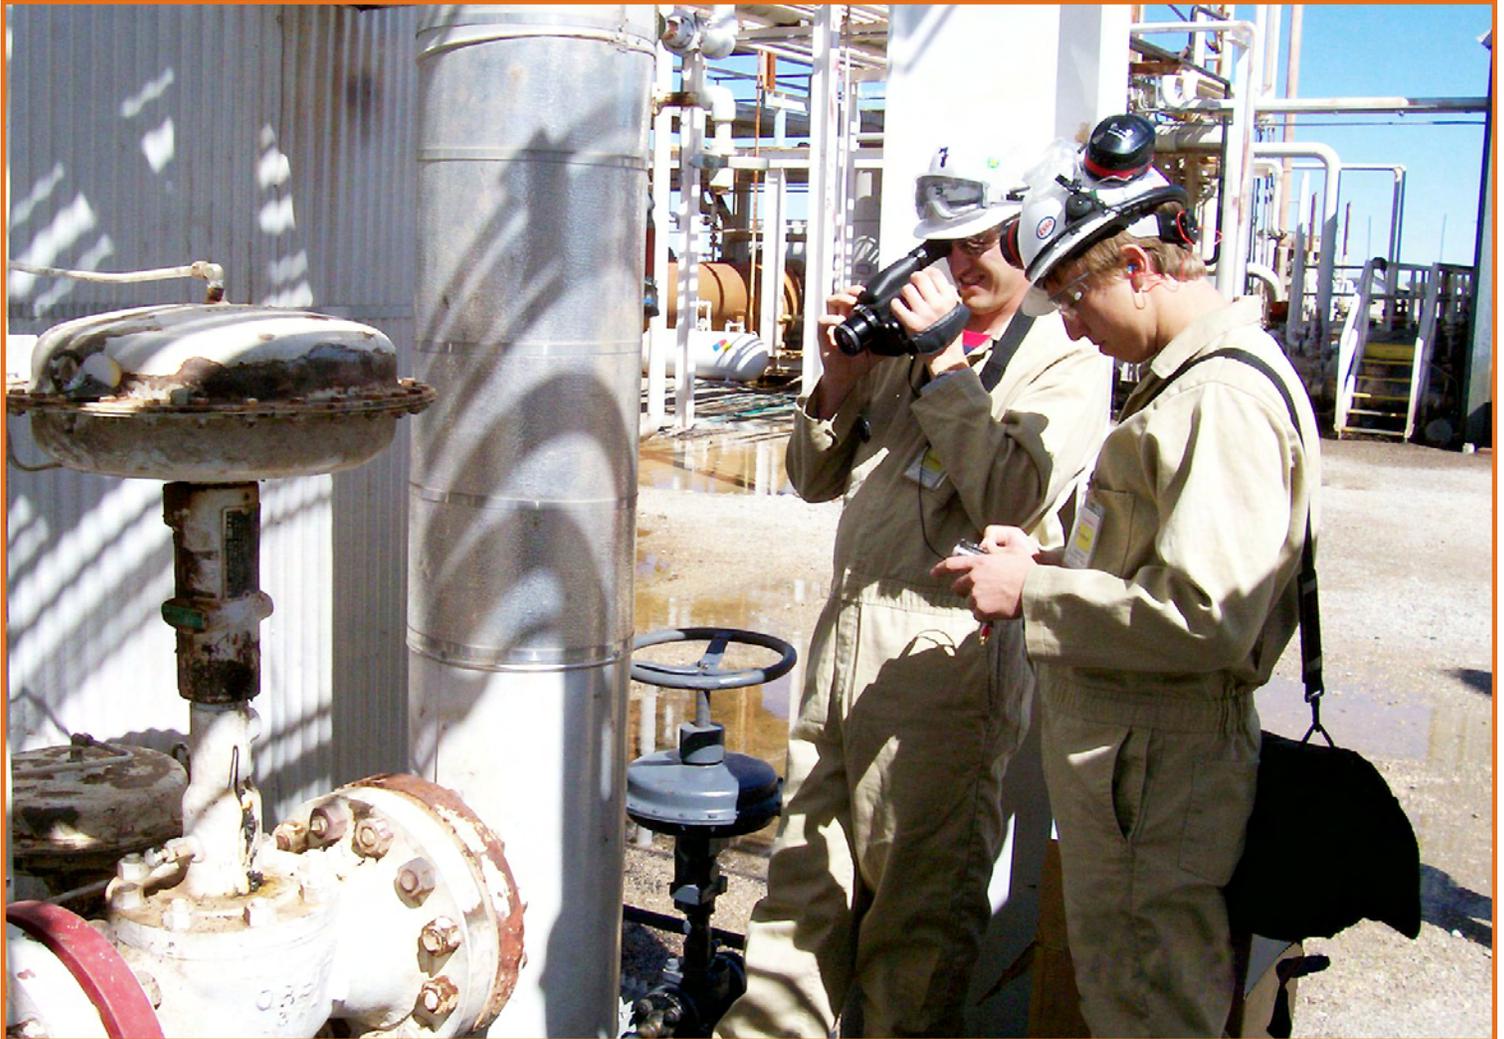
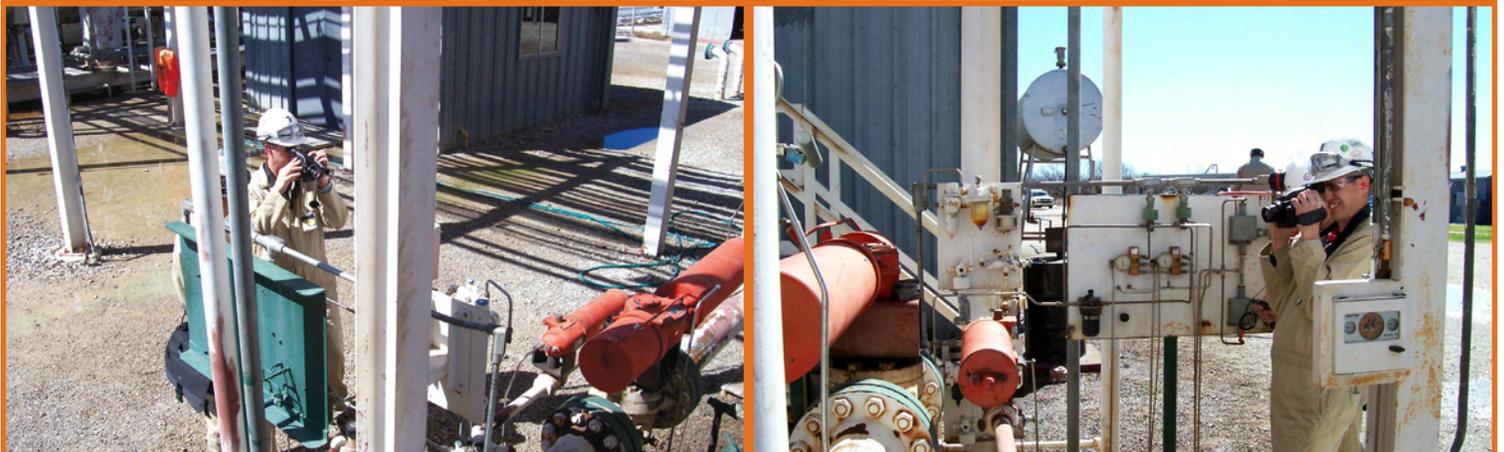
*A team from Leak Surveys, Inc. inspects various sections of a gas processing plant in north central Texas. The Hawk looks for leaks in compressors, control valves, flanges and unions. Photo by Leak Surveys, Inc.*
